# **2020 AHERA THREE-YEAR RE-INSPECTION REPORT FOR THE BETHEL HIGH SCHOOL**

**Bethel Board of Education**  
Bethel, Connecticut

**2020 AHERA/CTDPH  
THREE-YEAR REINSPECTION  
REPORT FOR THE  
BETHEL PUBLIC SCHOOLS**

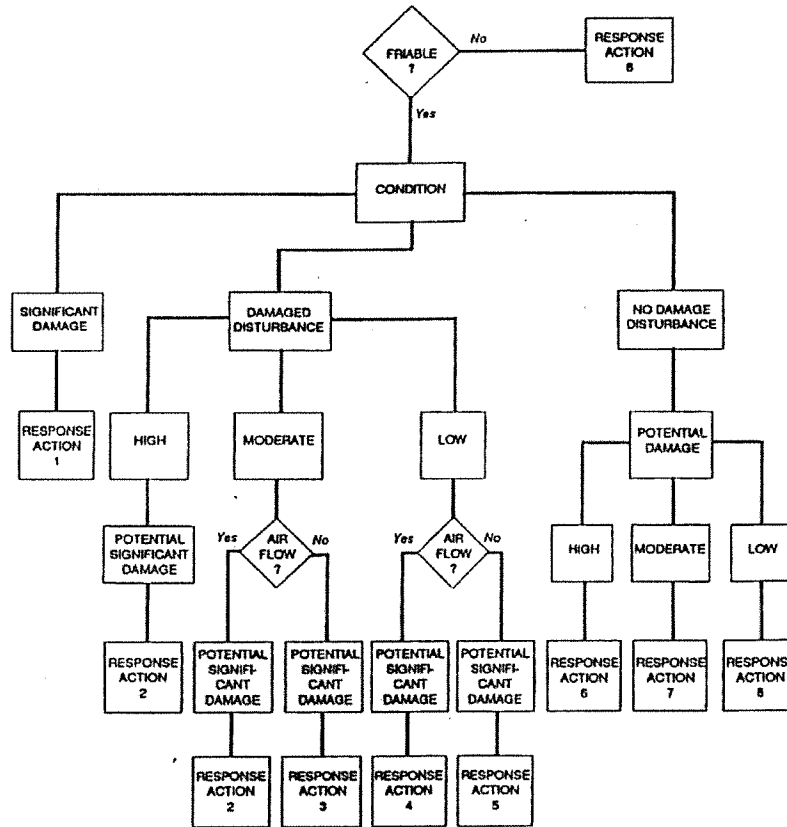
**FIGURE III-a  
EPA Decision Tree and  
Response Actions**

## EPA DECISION TREE AND RESPONSE ACTION KEY

RESPONSE ACTIONS KEY:	
1.	Isolate area and restrict access. Remove as soon as possible.
2.	Implement O&M. Remove as soon as possible or reduce potential for disturbance.
3.	Implement O&M. Schedule removal when practical and cost-effective, or reduce disturbance.
4-5.	Implement O&M. Schedule removal when practical and cost-effective. Number indicates priority for removal.
6-7.	Implement O&M. Take preventive measures to reduce disturbance. Number indicates priority for removal.
8.	Implement O&M until major renovation or demolition requires removal under NESHAPS or until hazard assessment factors change.
